## APPLICATION STORY

French national railways apply thermography for maintenance and use a FLIR Systems ThermoVision A40-M to inspect overhead catenaries at a speed of 120 km/h

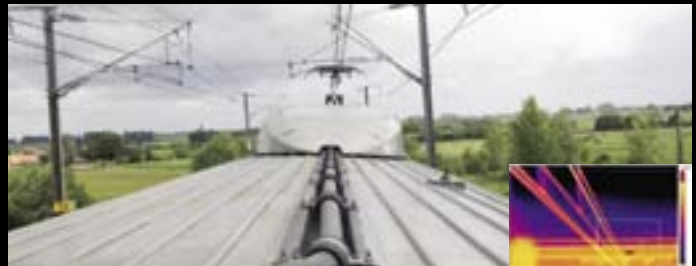
Picture by SNCF-CAV/ Jean-Marc Fabbro, 2006

A catenary is a system of overhead wires which supply electricity to a locomotive or a train, which takes the electricity through a pantograph. Catenary systems use at least two wires: a messenger wire or catenary supports the contact wire with vertical drop or connecting wires. The system is then suspended on pylons and subjected to mechanical tension. Picture shows a junction of two cables.

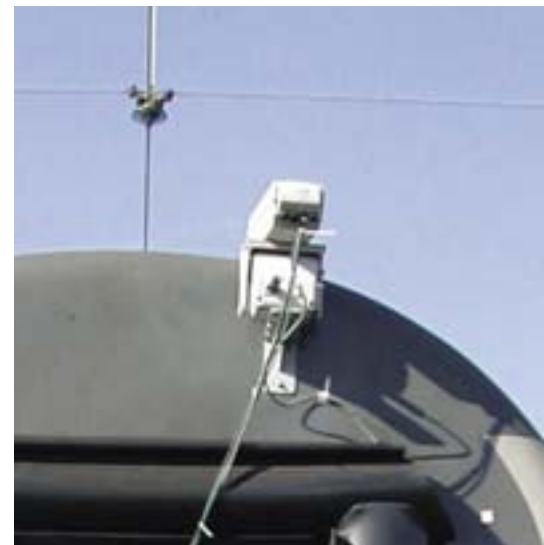
FLIR Systems ThermoVision A40 camera in housing placed on a test wagon.

special housing on a test wagon running at a steady 120 km/h (75 mph), a FLIR Systems ThermoVision™ A40-M fix mounted camera recorded the catenaries. Inside the wagon, a PC carried the ThermoCAM Researcher software suite to record the images. "The camera had to be rugged enough to stand in a housing outside a train wagon and it had to have an image frequency able to visualize the lines at that speed", said Millot. The ThermoVision A40, a fix mounted infrared camera with a 320 x 240 resolution, operating between -15 and +55 °C and offering an image frequency of 50 Hz, fulfilled these criteria. To geographically localize the hot spots on the lines, a mileage counter and an additional CCTV visual camera were installed. The visual camera also indicated whether hot spots on the catenaries were influenced by adjacent heat sources such as signals or lights.

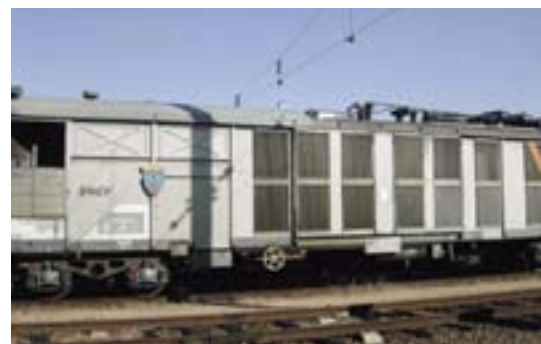
*The "Vulcain" SNCF test wagon, which in future will carry the infrared camera to inspect catenaries.*

But the experiment was a success. And the SNCF has already approved the development of a special wagon to inspect the catenaries of its nationwide electrified rail network. It would turn the French public railways into the first railway company to apply this inspection technique.

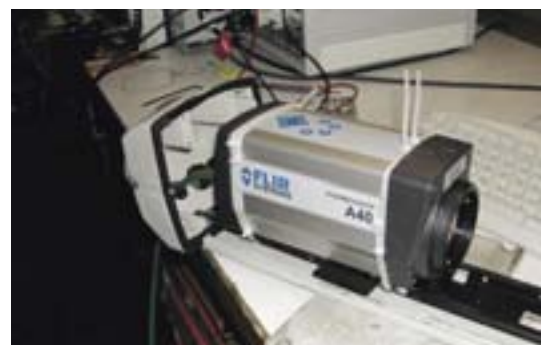
*Camera in housing.*

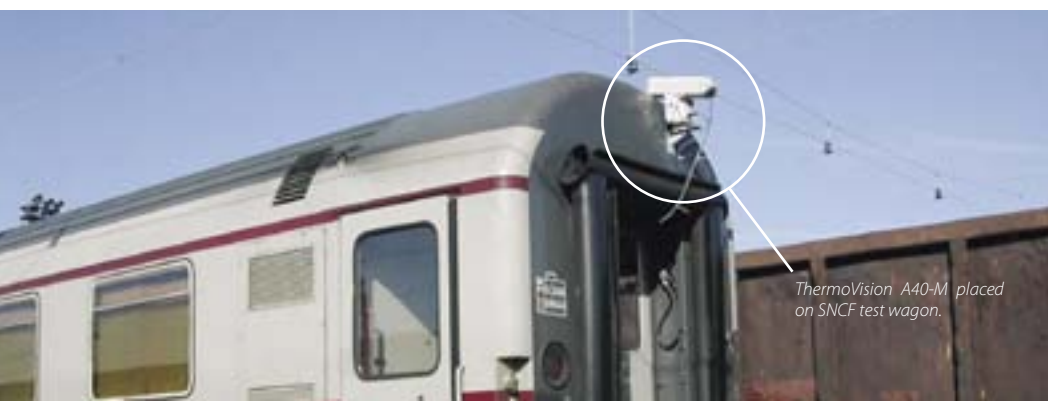
*ThermoVision A40-M placed on SNCF test wagon.*
