Infrared Camera increases output at shredder installation

Three FLIR Systems ThermoVision Infrared Cameras are being used to monitor the process of shredding scrap material at Stena Gotthard Fragmentering AB in Sweden. As a result, output at the installation has increased by more than 10%.

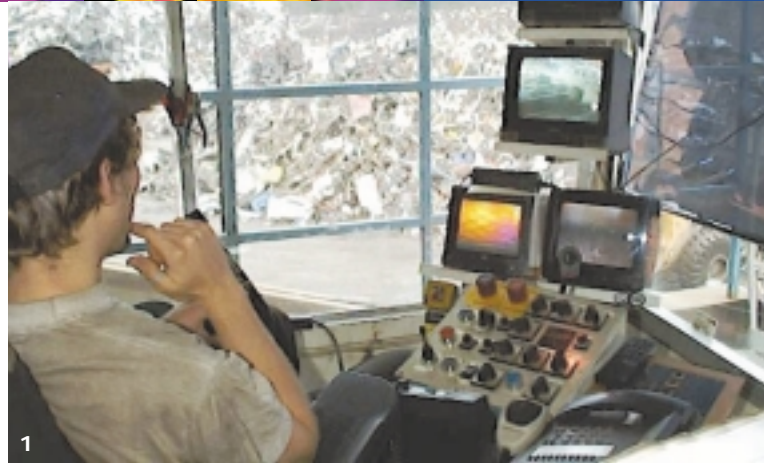
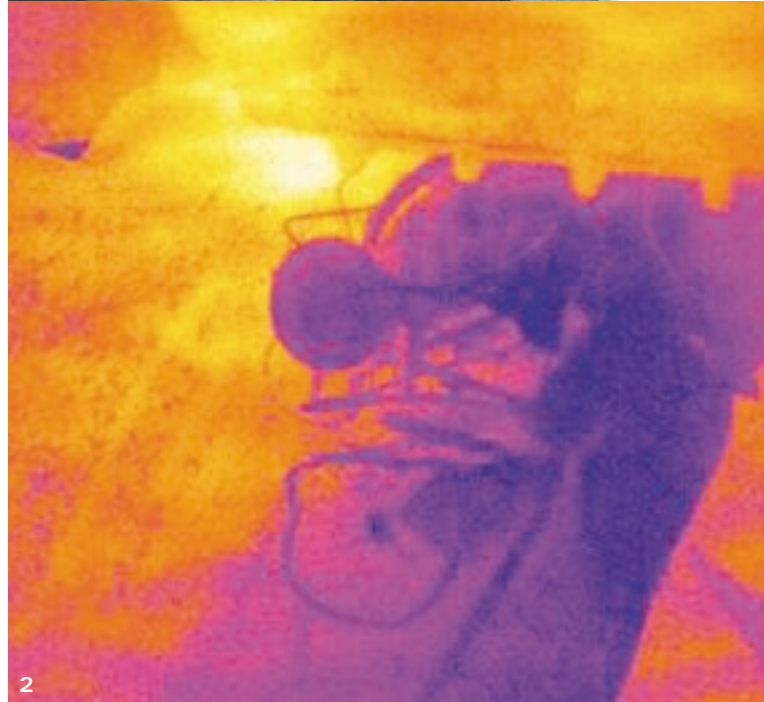
1. The control room with the IR display shown below left.
2. Bicycle being fed into the feeder.

At Stena Gotthard, the shredder operator can now view the IR image on the display in front of him while controlling the feeder with a joystick. "Before, I had to rely on an amp-meter to measure the electric current of the crusher and to indicate when something was choking the feeder," says Ola Kilestad, one of the shredder operators at Stena. "Thanks to the infrared camera, I can now see what is blocking the feeder through the smoke and take the appropriate action immediately."

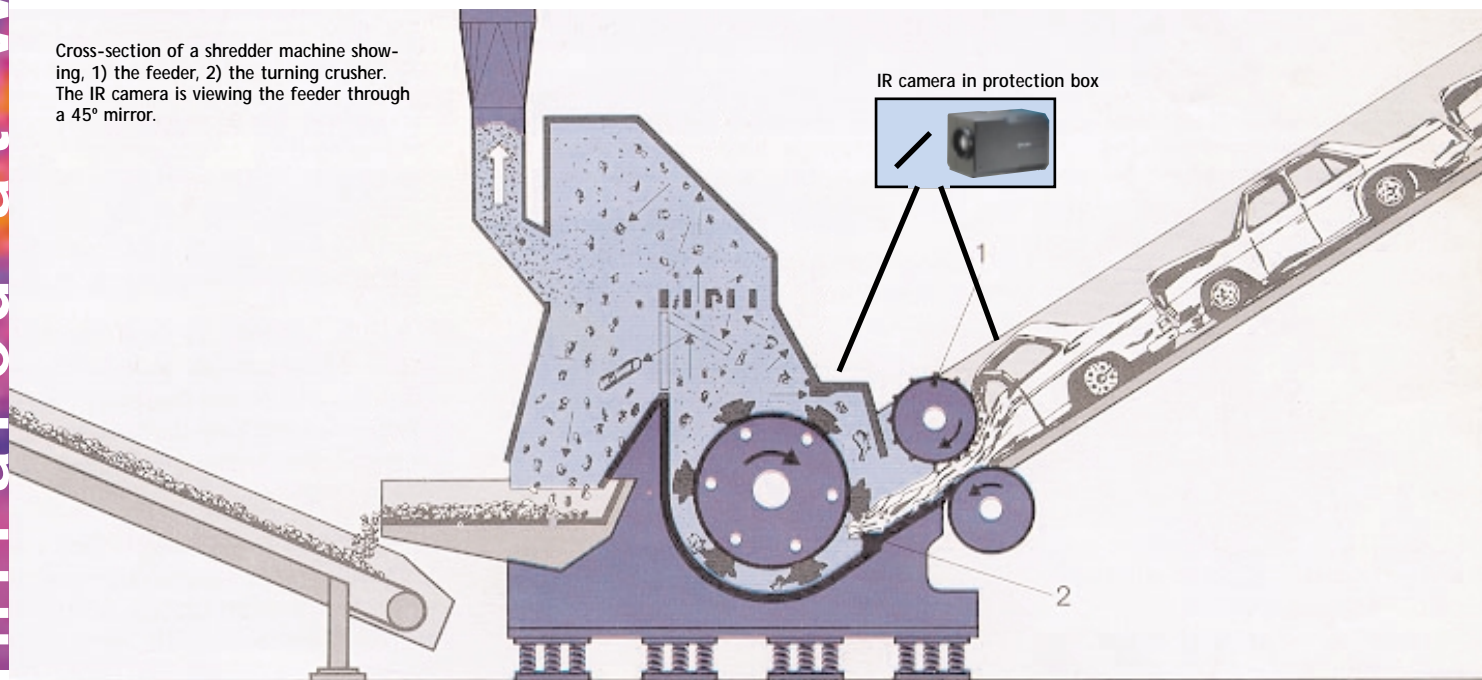
Cross-section of a shredder machine showing, 1) the feeder, 2) the turning crusher. The IR camera is viewing the feeder through a 45° mirror.

A cylindrical feeder, located above the crusher, loads the scrap into the shredder. In the control room, an operator manually controls the feeder to avoid the shredder from becoming choked. In the past, normal visual cameras were used to monitor the feeder. However, due to the smoke and steam, such cameras produced very poor image quality. The images were more or less useless to the operator.

By using an infrared camera, operating in the 8-12 μm spectral region, the operator is able to see through the smoke. A FLIR ThermoVision camera, installed above the feeder, gives the operator a real-time image that shows exactly what is going on inside the feeder.

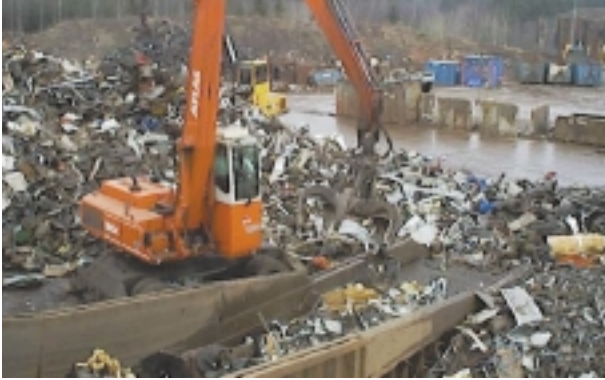
Loading scrap onto the conveyor belt.

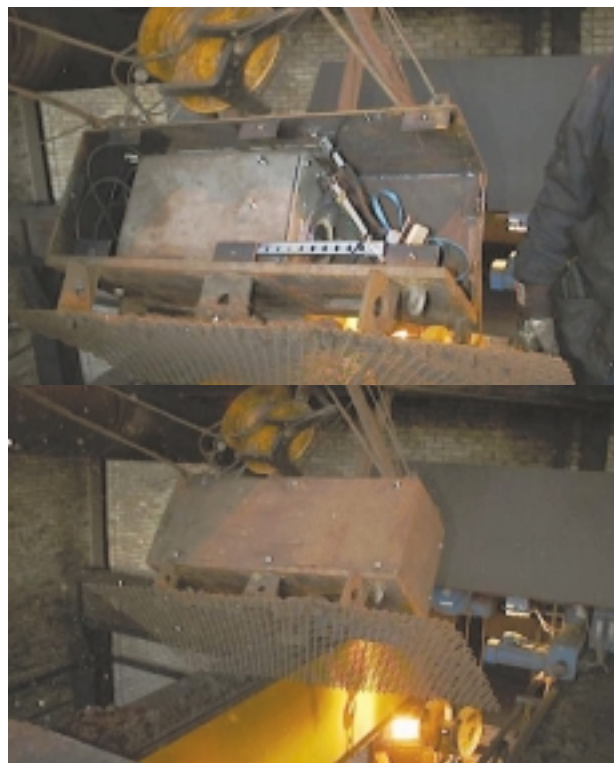
IR camera in protection box

The heavy-duty box, with the FLIR Systems ThermoVision camera inside, shown both open and closed here. The 45° mirror is easy to replace. The shock absorbing metal net is mounted on spacers welded to the thick bottom plate.

A crucial problem to solve was how to protect the camera. Smoke and dust coming out of the feeder are not the only problem; another is fragments of scrap that can sometimes be propelled at high, bullet-like velocity. In response, a local integrator, Informationssystem AB, helped Stena to build an adequate protection box. The bottom of the box is furnished with a 25 mm-thick, steel plate, which is further protected by a shock absorbing metal net. A 45° mirror is used to protect the front lens from direct exposure to the harsh environment. An air purger is connected to the enclosure to prevent dust from contaminating the mirror or camera optics.
